Precision 20/20
Full Reserve Study
for
Colonial Village
(Village II) a Condominium
Arlington, Virginia
July 8, 2013

Client: Colonial Village (Village II) a Condominium (Colonial Village II)

Location: Arlington, Virginia

Inspection Date: July 8, 2013. Reserve Advisors conducted the original Reserve Study in 2008.

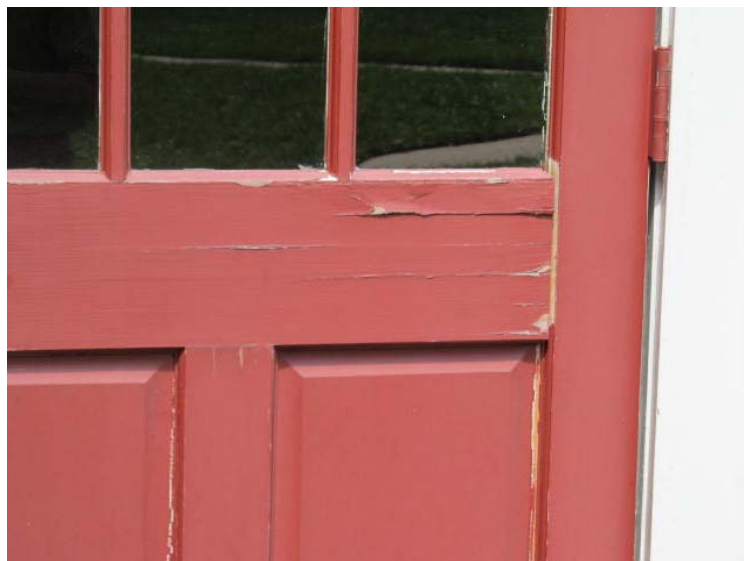
Doors, Entrances - Colonial Village II maintains a total of 51 front entrance common doors and service doors throughout the community. These doors are in fair to poor overall condition. We observe extensive wood deterioration and several locations of threshold gaps. Page 5.3 of *Photographs* depicts these conditions. The useful life of these doors is up to 30 years. We suggest that the Association budget for phased replacement of the doors beginning in 2014 and concluding by 2023. We include this information on Line Item 1.180 of *Reserve Expenditures*.

Significant deterioration of the door at Building 739

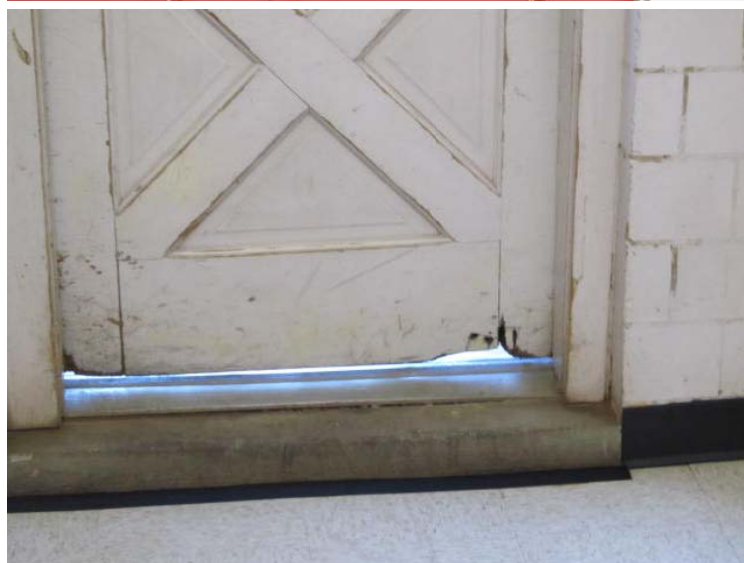
Gaps at the common door threshold at Building 1728

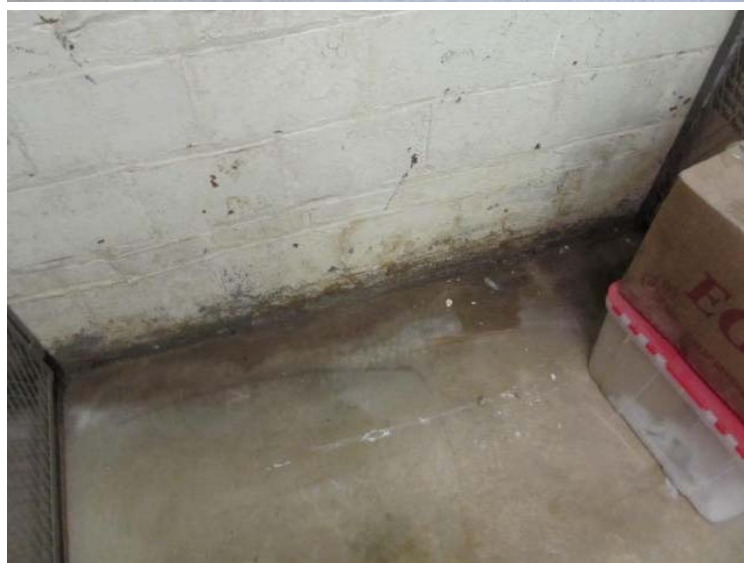
Foundations and Basements - Colonial Village II has a history of water infiltration into the common area basements. We observe active water infiltration, evidence of past water infiltration and previous repairs. Pages 5.3 and 5.4 of *Photographs* depict these conditions. Management informs us that the Association recently conducted repairs including waterproofing of basement walls and drainage improvements. In consideration of the water infiltration evident, we recommend the Association continue to budget for waterproofing and drainage improvements

Active water infiltration at basement

to the basements. We recommend the Association budget an allowance of \$15,000 plus inflation in 2014 and every two years thereafter. We include these anticipated expenditures on Line Item 1.193 of *Reserve Expenditures*.

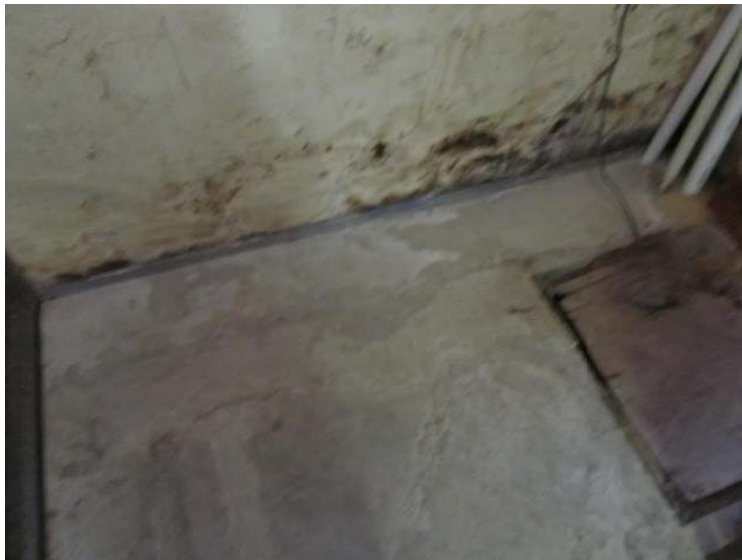
Evidence of past water infiltration at basement

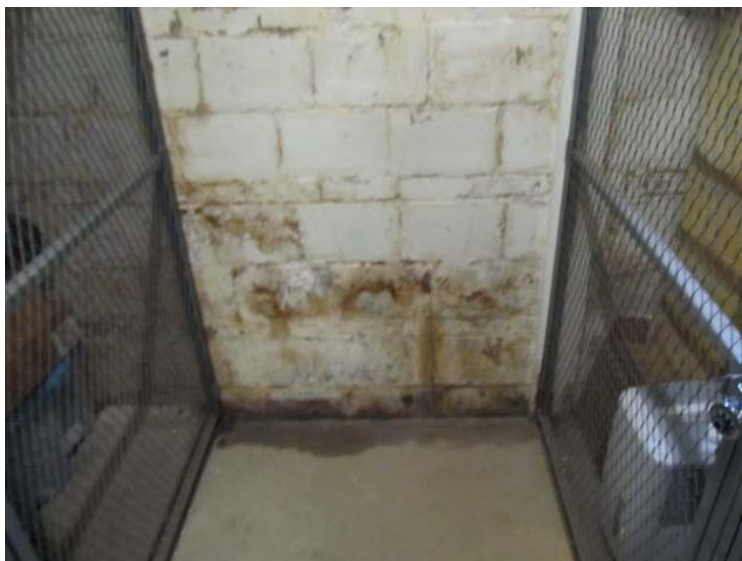
Active water infiltration at basement

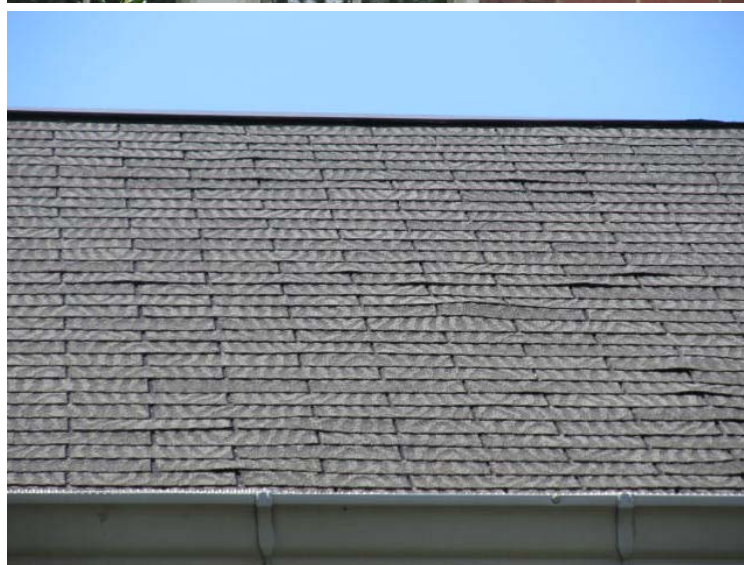
Roofs, Asphalt Shingles - Approximately 210 *squares*¹ of asphalt shingles comprise a portion of the roofs of Colonial Village II. The roofs include approximately 1,940 linear feet of gutters and downspouts. The gutters and downspouts are primarily aluminum and steel. The roofs are fair overall condition. Management informs us of no history of leaks. Our visual inspection from the ground notes shingle lift and deteriorated shingles. Page 5.5 of *Photographs* depicts these conditions. The useful life of asphalt shingle roofs in Arlington is from 15- to 20-years.

Typical asphalt shingle lift and deterioration

Based on their age and condition, we recommend that Colonial Village II plan to replace the roofs, including the gutters and downspouts as needed, by 2015 and again by 2035. We note this information on Line Item 1.280 of *Reserve Expenditures*. We base our cost on replacement with standard laminate Class A 240-260-pounds per square shingles. The Association should fund any repairs prior to the complete replacement of the roofs through the operating budget.

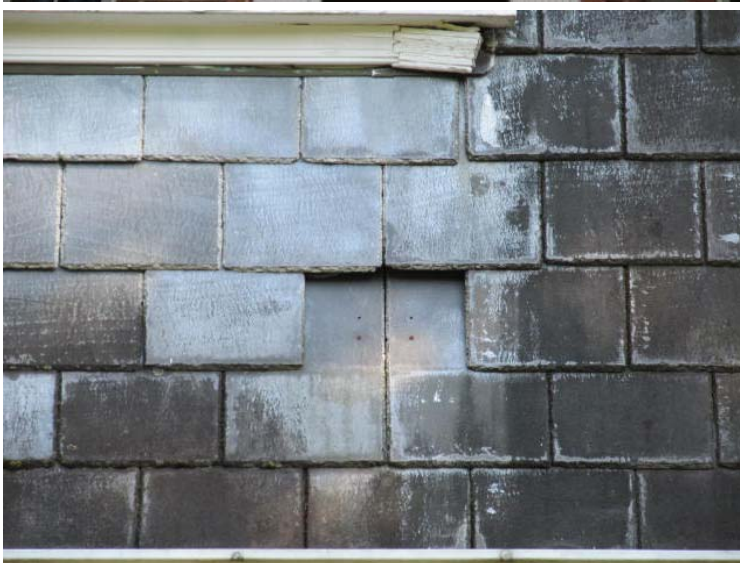
Roofs, Synthetic Slate - Approximately 70 squares of synthetic slate shingles comprise a portion the roofs of Colonial Village II. The roofs are in fair overall condition at an age of 29 years. Management informs us of no history of leaks. Our visual inspection from the ground notes deterioration and missing shingles. Page 5.6 of *Photographs* depicts these conditions. The useful life of a simulated slate roof is from up to 35 years. The occurrence of roof leaks will increase as more slate shingles crack, break and dislodge. As the shingles age they will begin flaking about their edges or delaminating followed by the occurrences of broken or dislodged

Missing synthetic slate shingle at Building 1806

Based on their age and visual condition, we advise the Association prepare for replacement of the synthetic slate roofs by 2019. We depict this information on Line Item 1.520 of *Reserve Expenditures*.

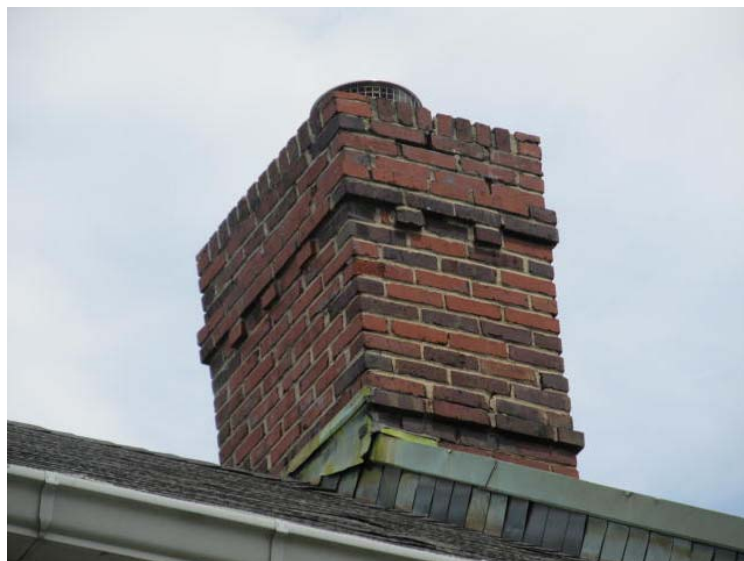
- Six chimneys total, including the incinerator chimney
- Three chimneys were recently repaired
- The three remaining older chimneys exhibit significant mortar and brick deterioration

Chimney in need of rebuilding at Building
1782 North Troy Street

In consideration of the observed condition of the chimneys, we recommend the Association budget rebuilding of the three remaining unrepaired chimneys in 2014. Our estimate of cost is based, in part, on a bid provided by Management.

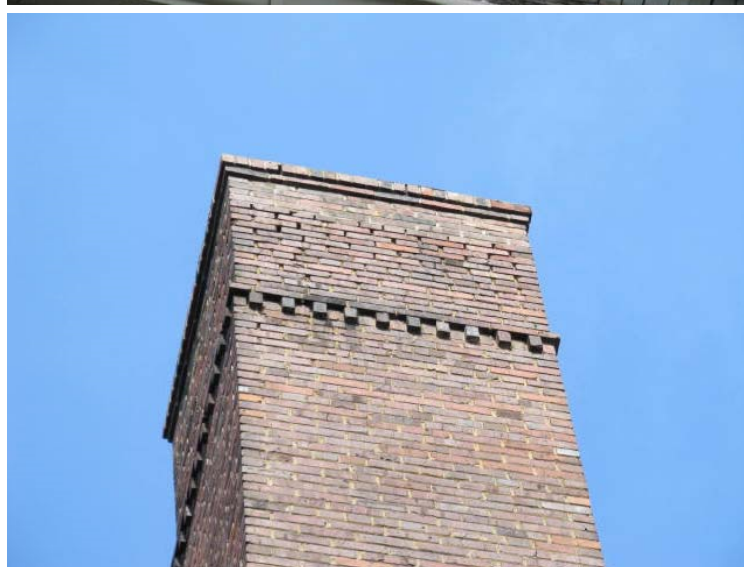
Incinerator chimney in need of rebuilding
at Building 1762 N. Rhodes Street

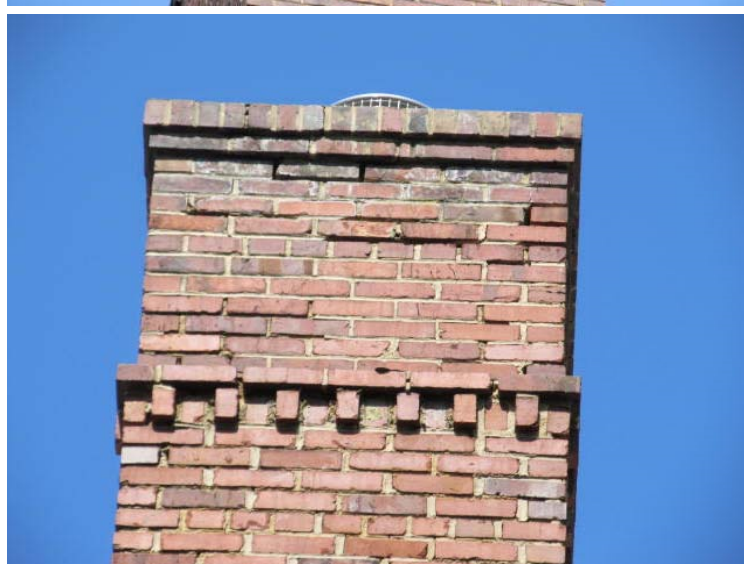
Chimney in need of rebuilding at Building
1728 North Rhodes Street

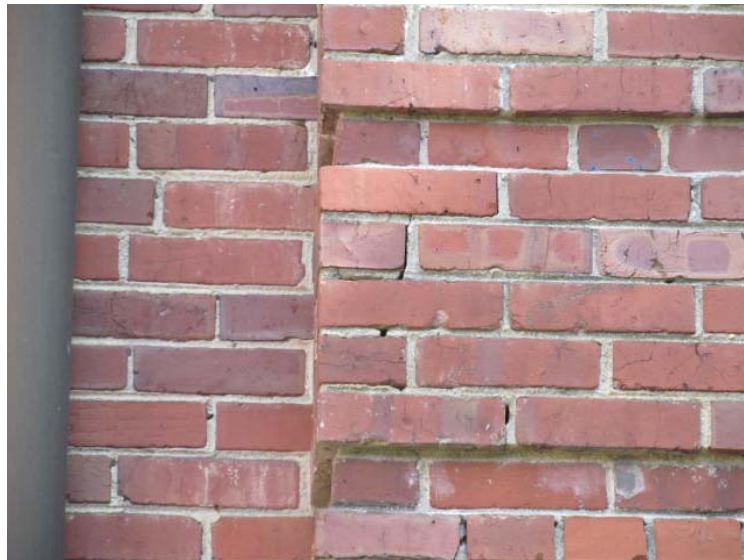
- Virginia Historic Landmark
- Extensive mortar loss and deterioration
- Lintel rust and deflected lintels
- Sill deterioration
- Brick spall

Mortar loss and deterioration at 1853 N. Rhodes Street

Pages 5.7 through 5.10 of *Photographs* depict these conditions. We advise a complete inspection of the masonry, and partial repointing with related masonry repairs every 8- to 12-years to forestall deterioration. We elaborate on solutions and procedures necessary for the optimal maintenance of masonry walls in the following discussion.

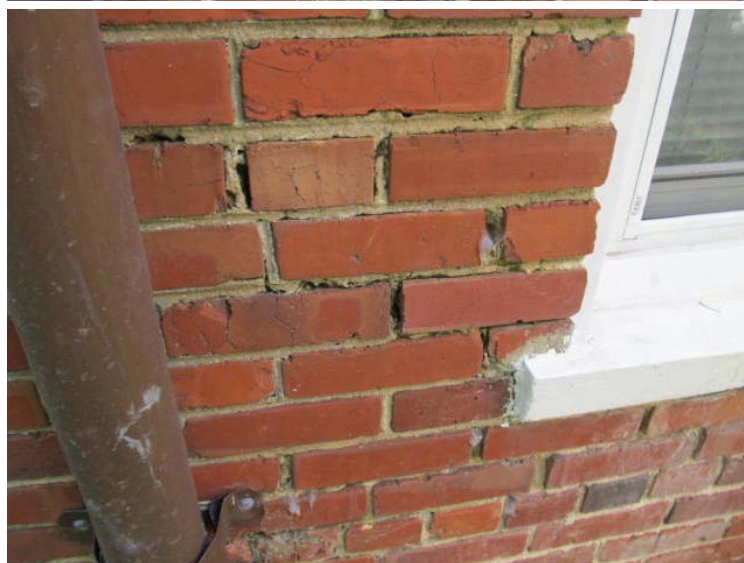
Mortar loss and deterioration at 1742 N. Rhodes Street

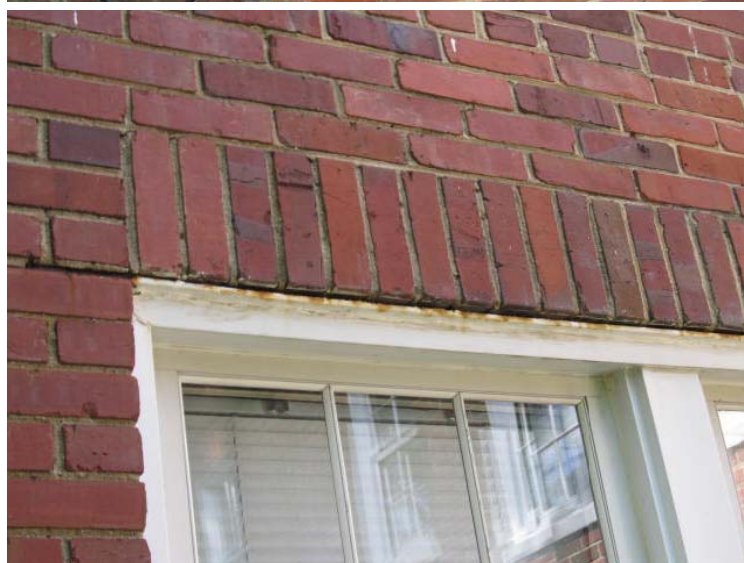
Metal lintel deflection and rust at N. Rhodes Street

With the onset of rust and deflection, a portion of the metal lintels will also require replacement during the next 30 years. Replacement of lintels includes the following activities:

- Removal of deteriorated lintels and surrounding masonry
- Installation of new pre-primed and painted metal lintels
- Installation of asphaltic flashing above the lintels
- Reinstallation of the masonry with new mortar and weeps

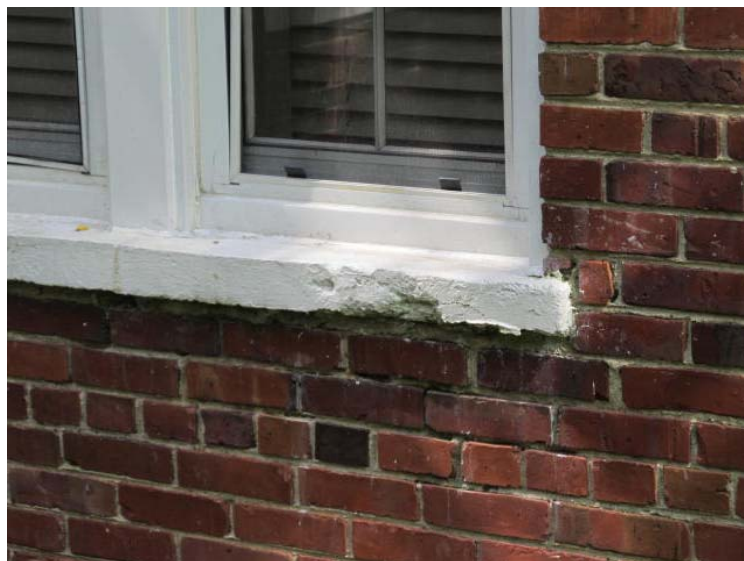
Sill deterioration at 1742 N. Rhodes Street

The contract for repairs should also include attention to other related activities such as repair and partial replacement of window sills, lintel beams and deteriorated masonry. We recommend the contract for masonry repairs include a thorough inspection of horizontal masonry such as copings or sills as these areas are prone to accelerated deterioration. Together, these aggregated capital repairs maximize the useful life of a masonry wall system.

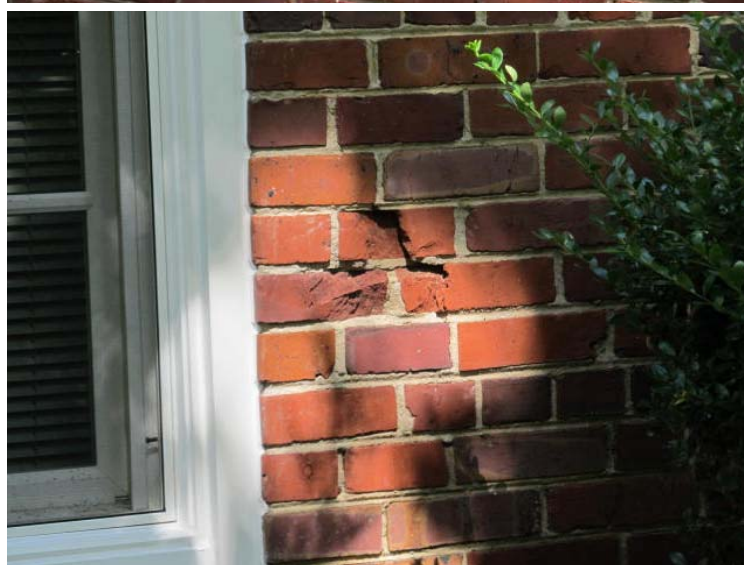
Brick spall at 1744 N. Rhodes Street

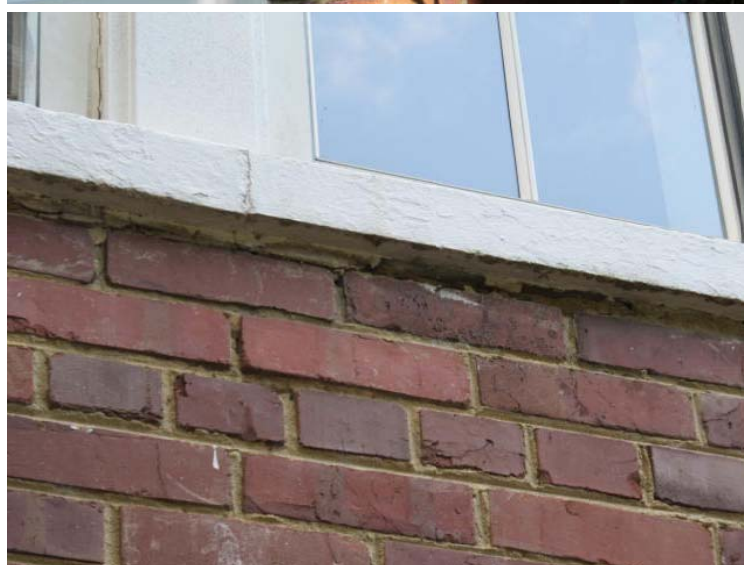
Mortar deterioration below sill at 1758 N. Rhodes Street

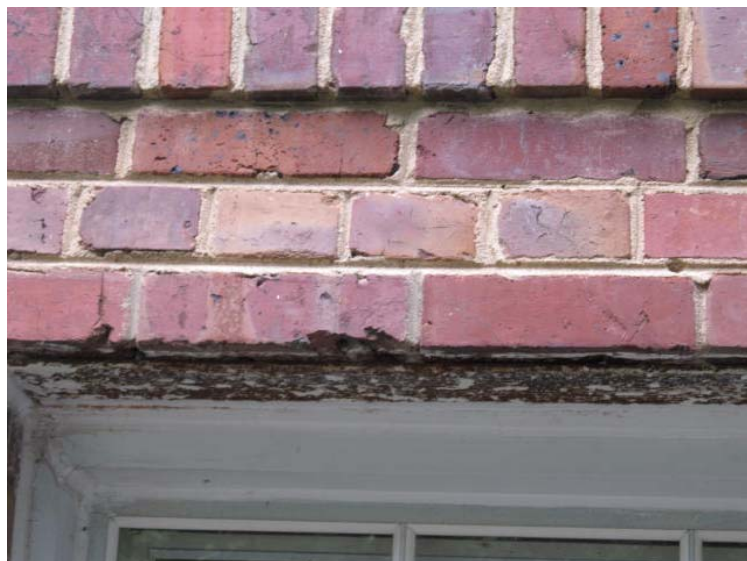
- Previous repairs at the upper portions of the masonry walls
- Minor mortar deterioration
- Lintel rust
- Efflorescence

Lintel rust and minor brick spall at 1782 N. Troy Street

We also recommend inspection, repair and replacement of the steel lintels. Lintels are structural supports or beams above windows and doors. Fatigued lintels also allow the direct penetration of storm water into the wall assembly. These inspections should locate areas of rust on the lintels and cracks or other structural damage to the walls around lintels. The contractor should remove any areas of rust, prime and paint these lintels. Paint protects and maximizes the remaining useful life of the lintels and therefore the exterior wall systems. Structural damage can eventually lead to costly replacements of lintels and surrounding wall systems. The following diagram details a metal lintel and weep system:

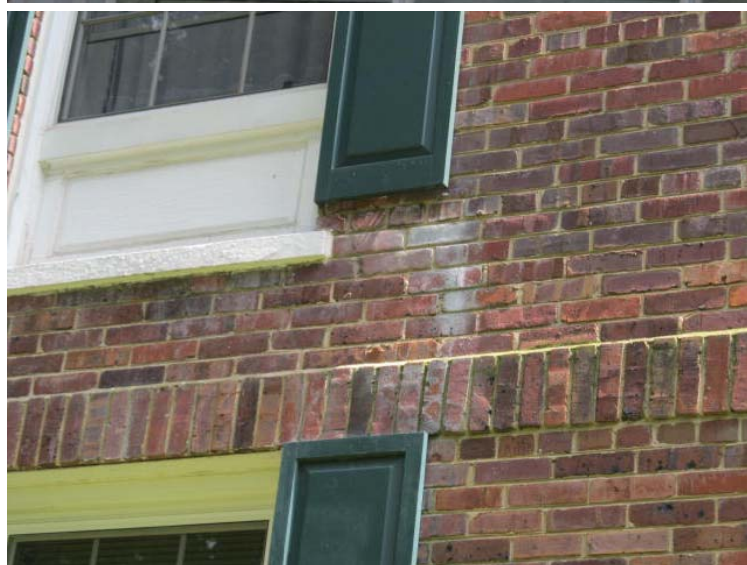
Minor efflorescence at 1741 N. Troy Street

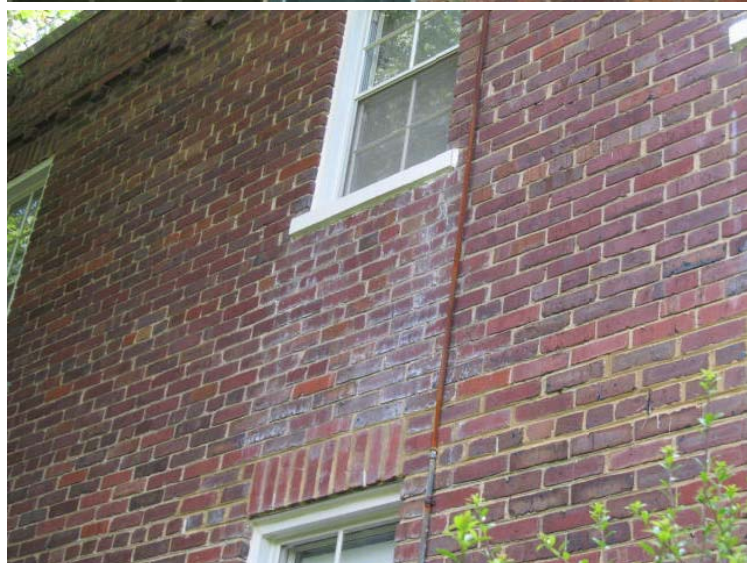
More significant efflorescence at 1739 N. Troy Street

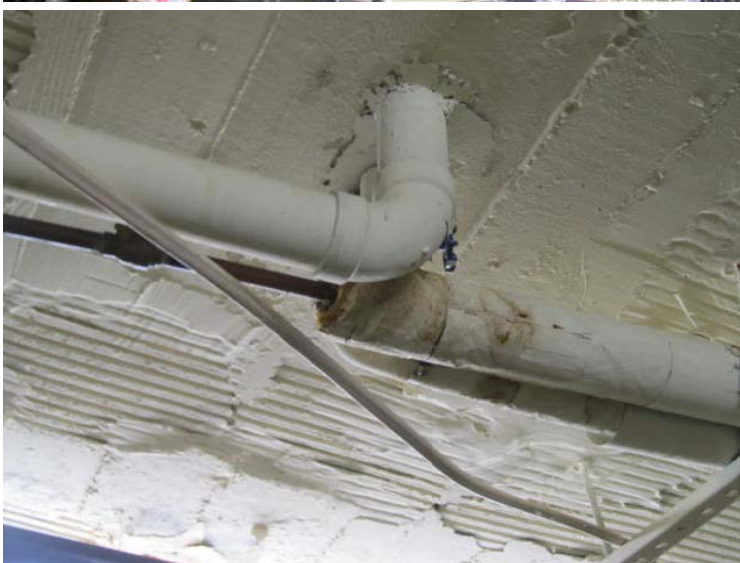
Discolored insulation at pipes is early indication of leak

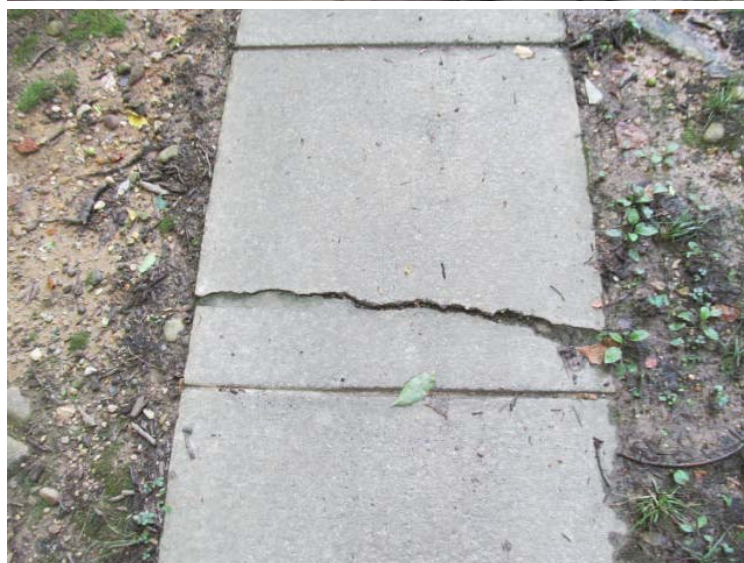
Sidewalk crack

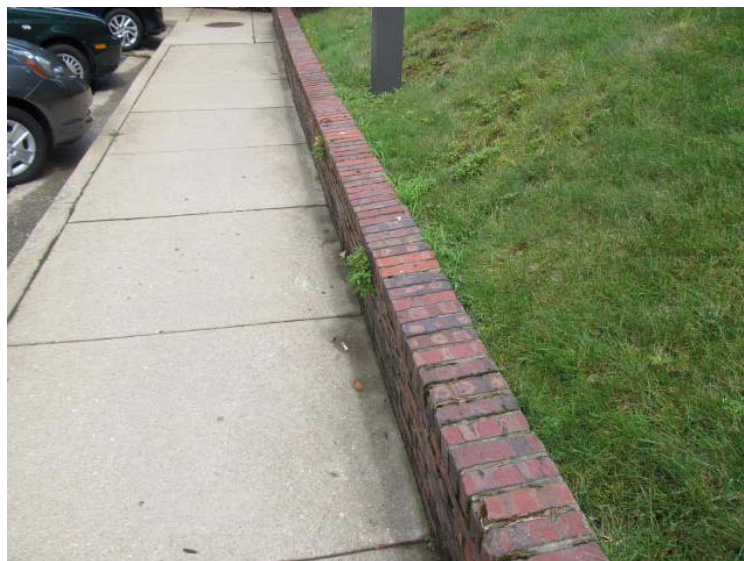
Slight retaining wall lean

4.740	9,300	3,100 Square Feet	Retaining Walls, Brick, Inspection and Capital Repairs	2016	8 to 12	3	4.00	12,400	48,754				13,159													16,041

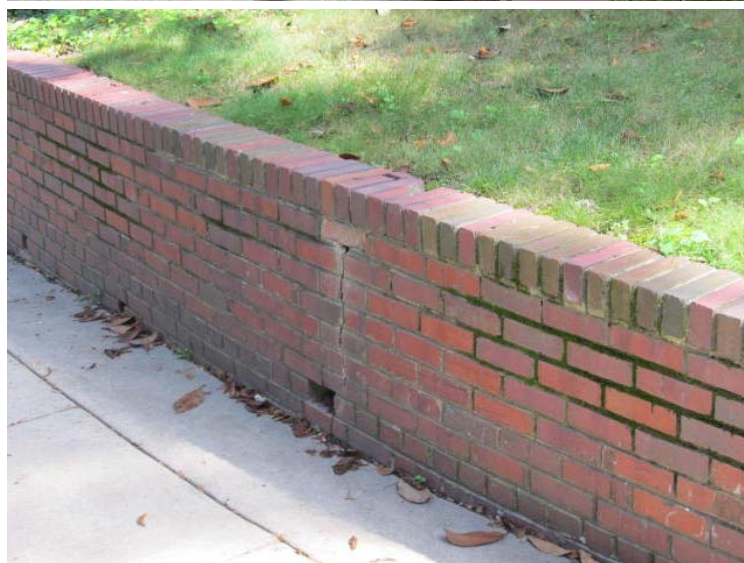
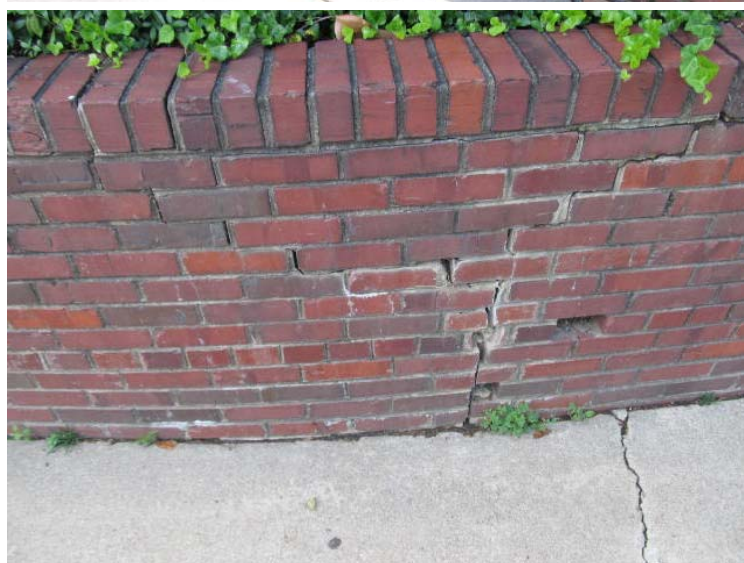
Retaining wall cracks and deterioration
