Colonial Villages II Board of Directors
1903 N. Key Boulevard
Arlington, VA 22210

RE: Colonial Villages II Lighting Study

February 11, 2014

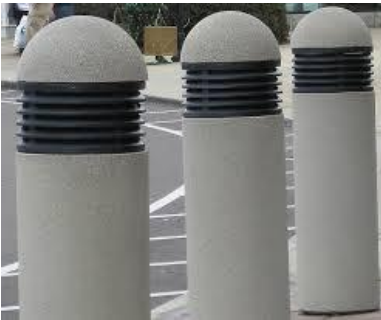
Many of the bollards along the walkways have been damaged by abuse, and this is an issue that I understand has been an ongoing concern. Not only have certain bollards been knocked over in the past, but their plastic lenses have been damaged in many cases; apparently, the lenses are not able to be re-ordered, resulting in an ongoing damaged appearance to the bollards.

To permanently prevent this from recurring in the future, concrete bollards that do not have transparent lenses that can be damaged could be considered. One image of such bollards is as follows:

Using LED technology as the lighting source in the bollards would reduce electricity use by approximately 50% and extend longevity by approximately 4 times to 50,000 hours; this means no maintenance for approximately ten years. A total of sixteen bollards were counted on site.

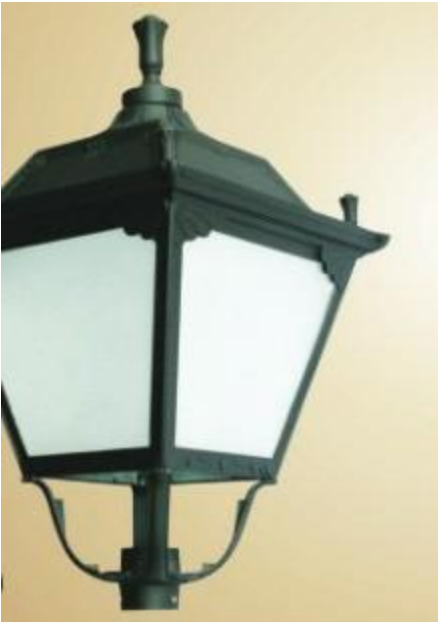
The style of the current shoebox fixtures is likely appropriate, as their downward facing positioning prevents light trespass into many of the living units in close proximity. However, it could be argued that a traditional colonial style might be desirable. Such a style is as follows:

The colonial fixture represented in the above fixture can serve as a direct replacement for the five colonial fixtures in the courtyard of the Troy Street residential area; the 150-watt mercury vapor system could be replaced with a 70-watt induction fixtures, increasing longevity by approximately 7 times, reducing electricity by approximately 50%, and eliminating lighting maintenance for approximately 21 years.
